National Dam Inspection Program. Lake
Rene Dam (Lake Rene) (NDI PA-426, DER
17-102), Ohio River Basin, Tributary of
Narrows Creek, Clearfield County,
Pennsylvania. Phase I Inspection Report.

PHASE I REPORT
NATIONAL DAM INSPECTION PROGRAM

NAME OF DAM: Lake Rene Dam
STATE LOCATED: Pennsylvania
COUNTY LOCATED: Clearfield County
STREAM: Narrows Creek, a tributary of Sandy Lick Creek
DATE OF INSPECTION: April 2, 1979 and May 4, 1979

LAKE RENE DAM
NDI I.D. NO. PA-426
APRIL 2, 1979

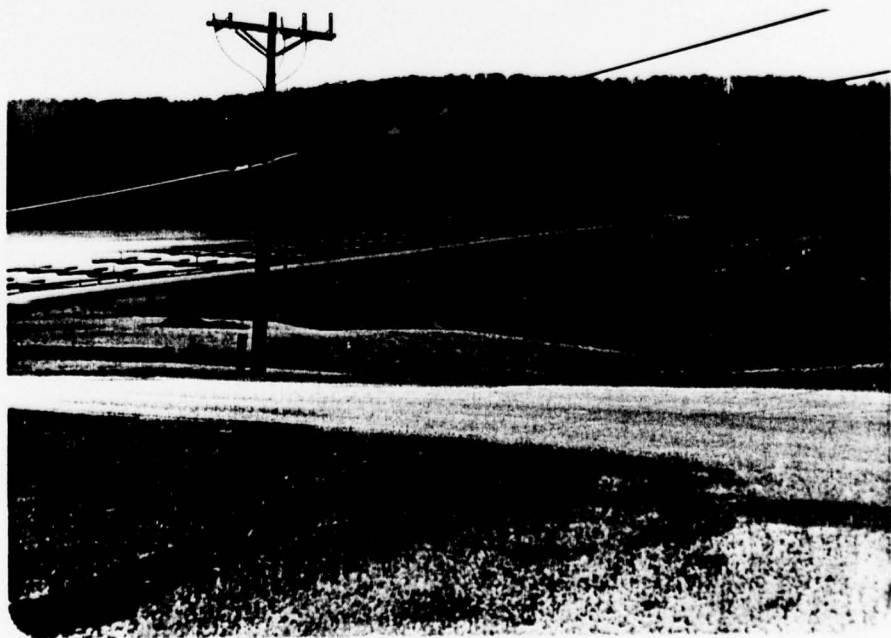
Downstream Face

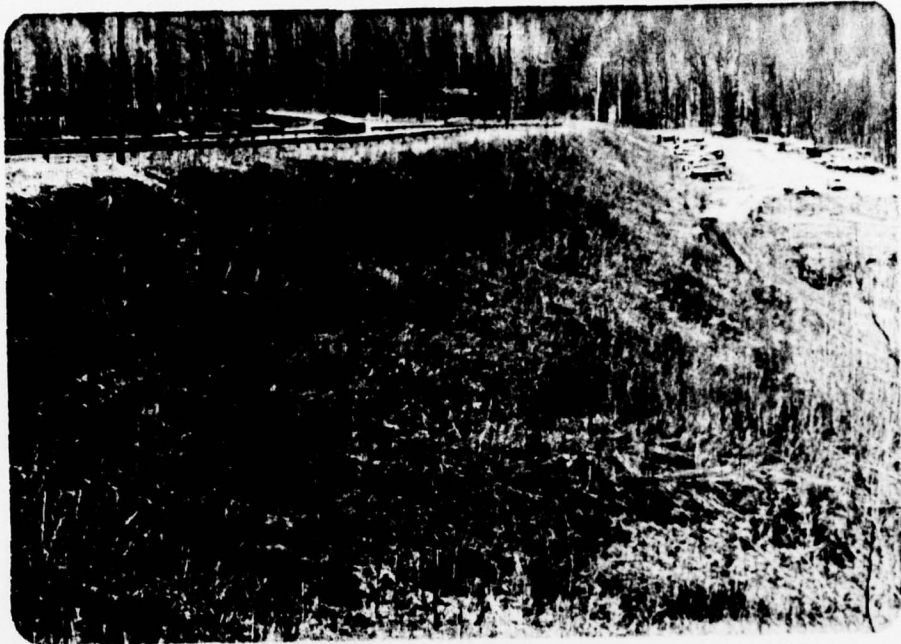
In general, the condition of the dam is considered to be poor. Numerous seeps, wet areas, and slumps were found on the downstream face of the dam extending approximately from the midheight of the embankment to the toe level. Total flow from three seepages near the right abutment at the toe level was estimated to be about 5 gallons per minute. Flow from another seepage located on the left side of the outlet pipe was estimated to be approximately 10 gallons per minute. The downstream face of the dam is very irregular with varying slopes. The top 15 feet of the downstream slope was estimated to be on 1.3 horizontal to 1 vertical slope. The remaining portions are 2 horizontal to 1 vertical or flatter. While most of the downstream slope is covered with brush, a section near the right abutment is covered with trees up to four inches in diameter and 15 to 20 feet high. The upstream slope of the dam has no erosion protection and the shoreline is irregular. It appears that most of the shoreline irregularities are caused by wave erosion.

Photograph No. 1
Downstream face (looking north).

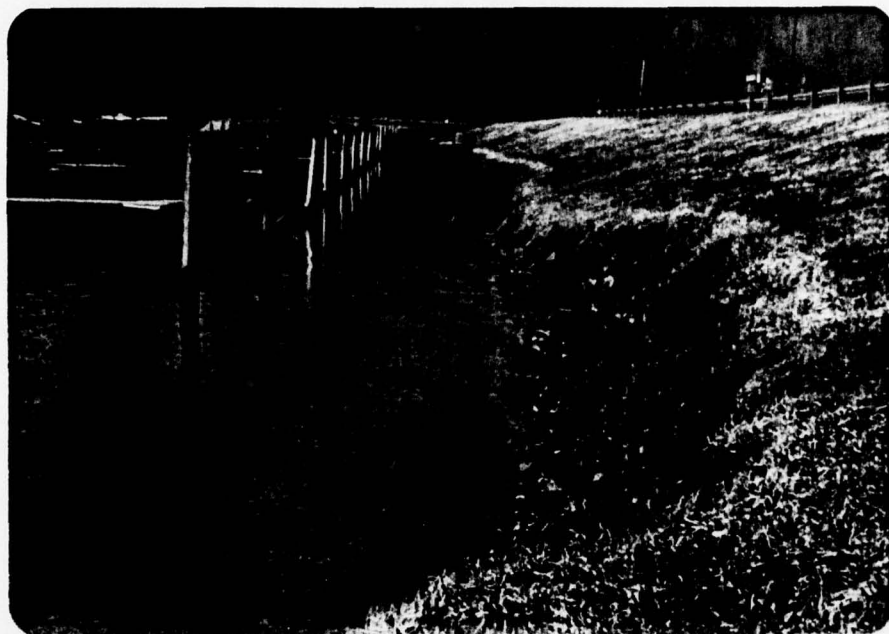
Photograph No. 3

4.2 Maintenance of the Dam. The maintenance condition of the dam is considered to be poor. It appears that no attempts have been made to control the seepage and slumps on the downstream slope of the dam. The downstream face of the dam is covered with brush and trees up to four inches in diameter and 15 to 20 feet high. The upstream face of the dam is irregular and appears to be eroded by wave action.

Upstream slope shoreline erosion.

2. The upstream face of the dam should be provided with adequate erosion protection to avoid further shoreline erosion.
3. Around-the-clock surveillance should be provided during unusually heavy runoff and a formal warning system developed to alert the downstream residents in the event of emergencies.
4. The dam and appurtenant structures should be inspected regularly and necessary maintenance performed.

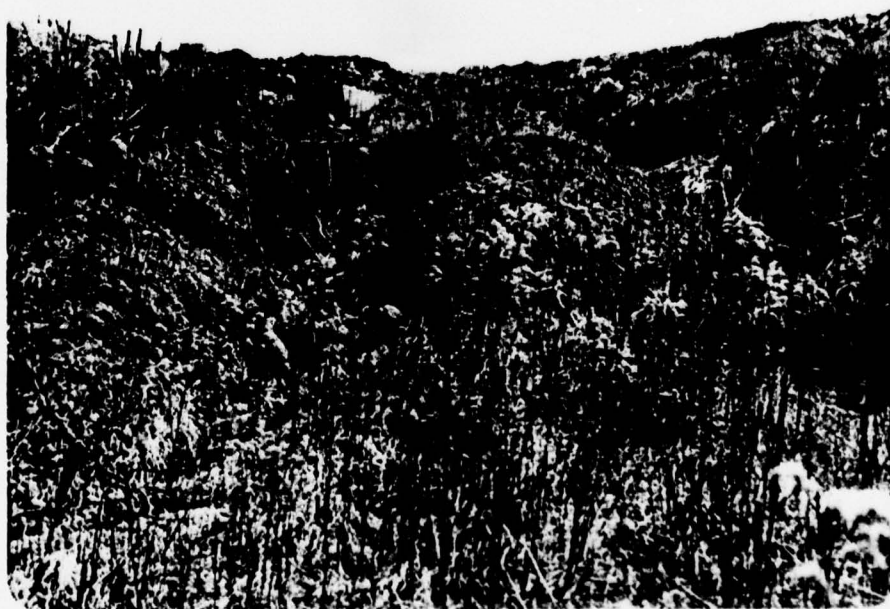
Photograph No. 4

VISUAL EXAMINATION OF	OBSERVATIONS	REMARKS OR RECOMMENDATIONS
JUNCTION OF EMBANKMENT AND ABUTMENT, SPILLWAY AND DAM	A major erosion ditch at the junction of the right abutment. Erosion ditch and seepage at the junction with the left abutment.	The erosion ditches should be filled and seepage should be controlled.
ANY NOTICEABLE SEEPAGE	There are numerous seeps and wet areas on the downstream slope extending from the midheight of the embankment to toe level. See Plate 6 for location of wet areas and seepage points.	
STAFF GAGE AND RECORDER	None.	
DRAINS	None.

Erosion ditch at right abutment-embankment
junction.

4.5 Evaluation. The overall maintenance condition of the dam is considered to be poor. The dam has no functional outlet works. It is therefore recommended that either the outlet conduit should be equipped with upstream flow control facilities or other means of drawdown should be provided. The brush and trees on the downstream face of the dam should be removed and erosion ditches should be filled.

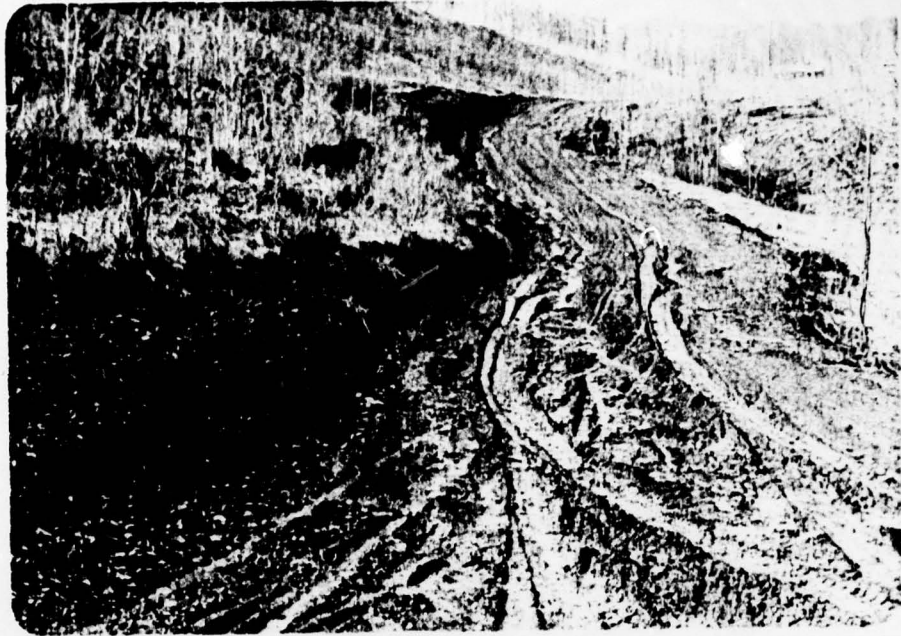
Photograph No. 5

There are numerous seeps and slumps on the downstream face of the dam starting from midheight of the embankment extending down to toe level.

3.2 Evaluation. The overall condition of the dam is considered to be poor. The most significant conditions noted were the presence of extensive wet areas and associated slumps on the downstream face of the dam which raised concern as to the continued stability of the embankment. The upstream slope of the dam has no erosion protection and is therefore susceptible to wave erosion. Although the dam has an outlet conduit, there is no means of controlling flow through this conduit. Reportedly, the upstream end of this conduit is plugged by a steel plate which can be removed by pulling a chain attached to the steel plate. This method of controlling flow through the outlet conduit is considered to be unacceptable.

Seepage and slumps at center of embankment
about 35 feet below crest level.

1. The owner should immediately retain a professional engineer for detailed evaluation of the dam and the outlet structures and to prepare and execute plans for (a) controlling seepage and slumping on the downstream face of the dam, (b) evaluating the integrity of the embankment in view of the observed conditions, (c) evaluating the integrity of the outlet conduit, (d) providing emergency drawdown facilities. The detailed evaluation of the dam should include, but not be limited to, subsurface investigation, materials testing, and stability and seepage analyses.
